## MEMORANDUM

| <b>SUBJECT:</b> | March Weekly Progress Report @ Gold King |

**Project:** Gold King Interim Water Treatment Plant (IWTP)  
**Location:** Gladstone, Colorado  
**Prepared for:** Emergency Response Unit – US EPA Region 8

**Reporting Period:** Apr 4 – Apr 11  
**Report No.:** 16

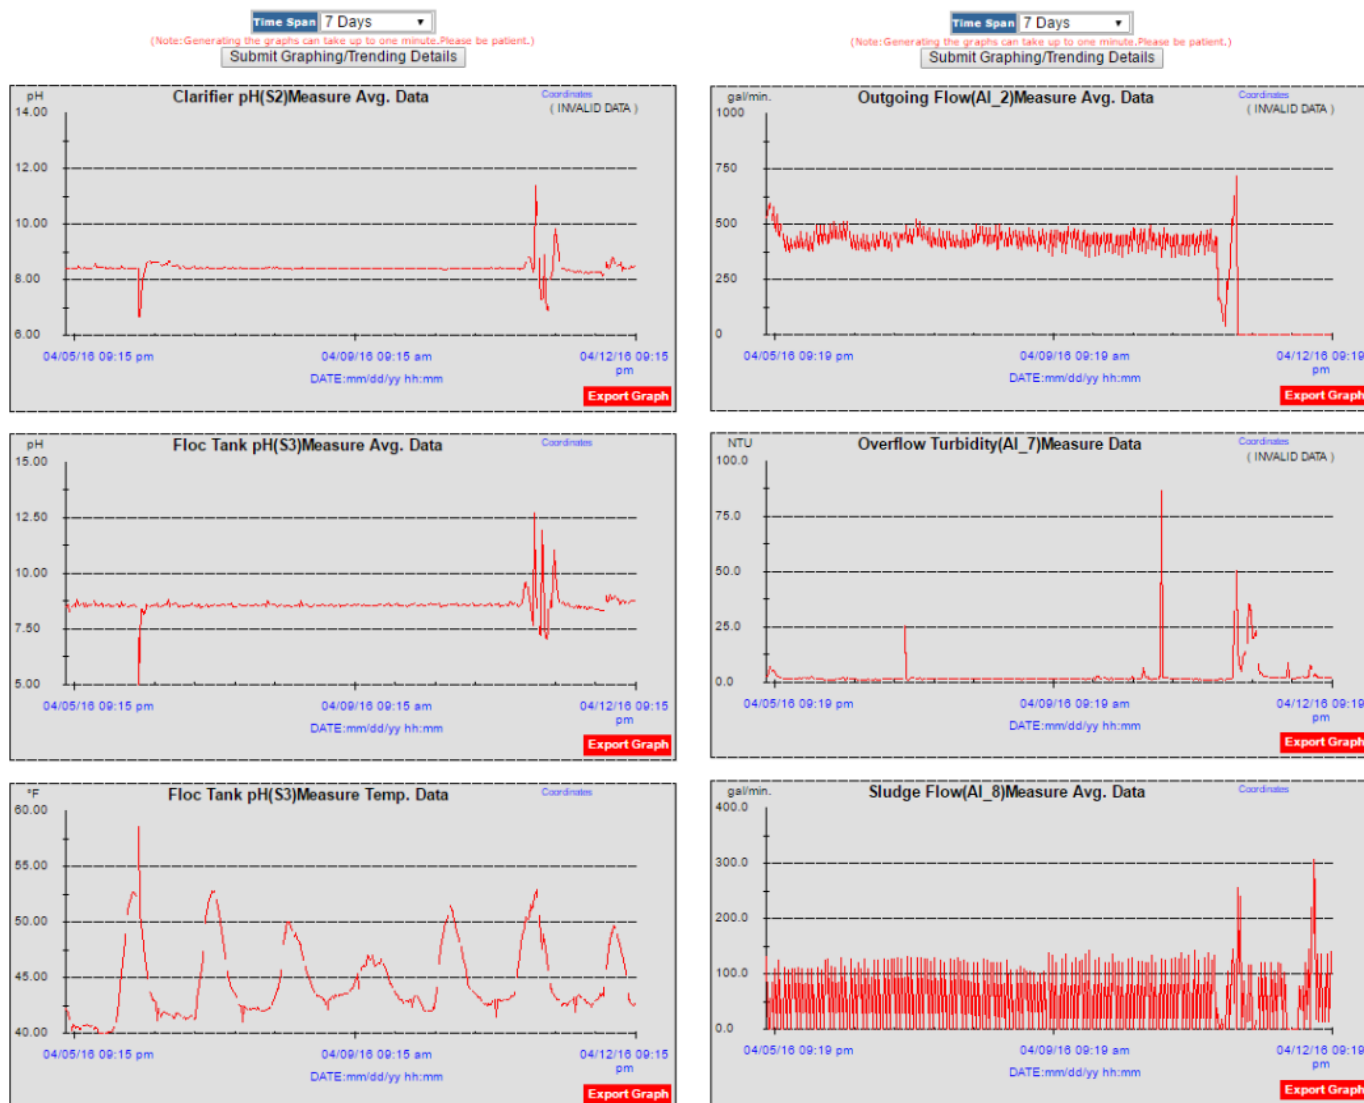
- The following graphs provide trending information collected by datalogging equipment during the previous 7 days. These dataloggers collect control information from the Lime Circuit (left) and Flow Circuit (right) Programmable Logic Controllers (PLCs) at the Gold King IWTP. Over the reporting period (4/4/16 – 4/11/16 inclusive) Alexco treated 4.27 million gallons at an average flow rate of 423 gpm with all discharged treated water leaving the 12" HDPE pipeline.

- Please note: Several days each week, the Alexco operators check the pH at both the flocculation tank and clarifier discharge. During this time, the probe is placed in vinegar (acid), and three pH buffers – 4, 7, and 10. While the probe is in the acid/buffer, the datalogger may capture one of those points for tracking purposes, which explains the occasional pH spikes seen on the graph. For example, on 4/6/2016 the Alexco operator soaked both pH probes in acid to remove build-up of calcium on the glass bulbs. This can be seen in the short drop in pH at both the flocculation and clarifier pH probes.

- On 4/7/2016 and again on 4/10/2016, the Alexco operator cleaned out the turbidimeter, which caused a brief spike in NTUs.
- On 4/11/2016 at 11:00am the Alexco operator shut-off flow to the plant and backed up water in the upper ponds. During this time, a vac-truck removed collected solids from the bottom of the lime slurry tank which have been causing peristaltic lime pump failures. The material was removed and deposited on the sludge bag liner in the A cell. Soon after the plant was restored to operator, but did experience some overshoot and undershoot issues with the pH set-point during dewatering of the upper ponds. Within a few hours the system returned to normal operation.

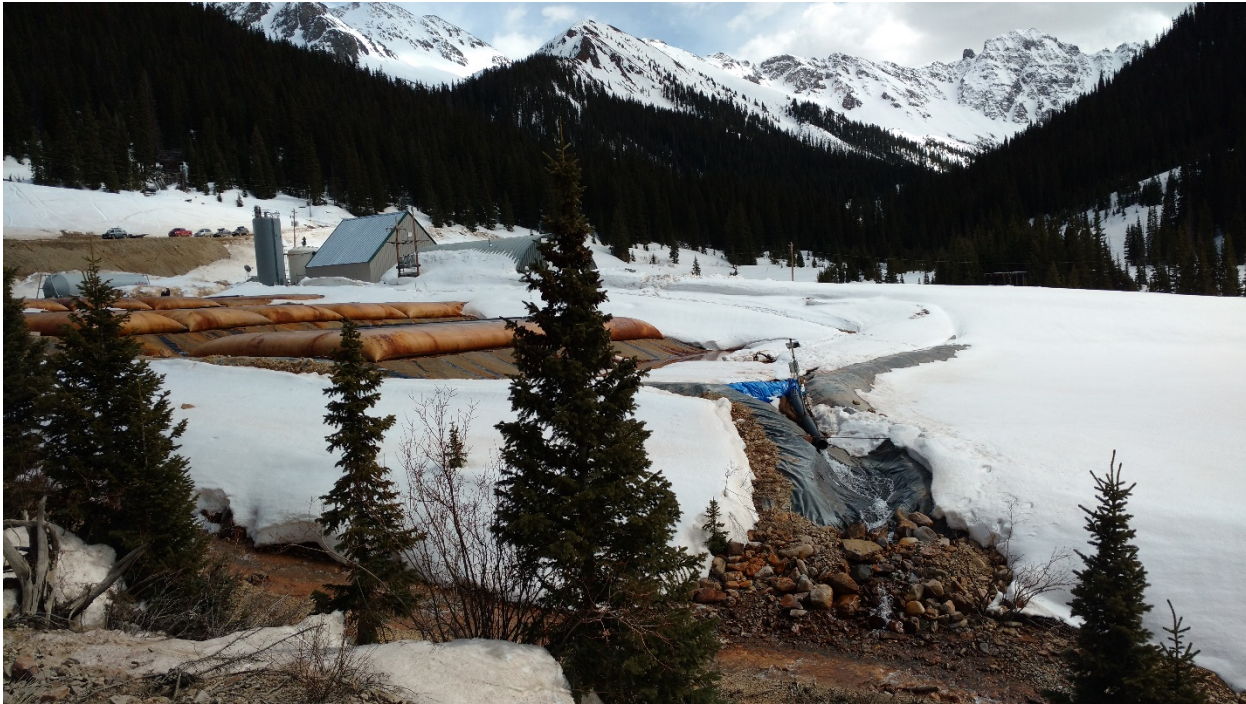
Figure 1: Site from road near discharge – Taken on 4/11/2016
